**BUILDING EVALUATION REPORT
BASED UPON VISUAL OBSERVATIONS
AT**

“CAPTAIN WILLIAM TYSON HOUSE”

**49 EAST PASSAIC STREET
TOWNSHIP OF ROCHELLE PARK
BERGEN COUNTY, NEW JERSEY**

JUNE 1, 2015
PREPARED BY

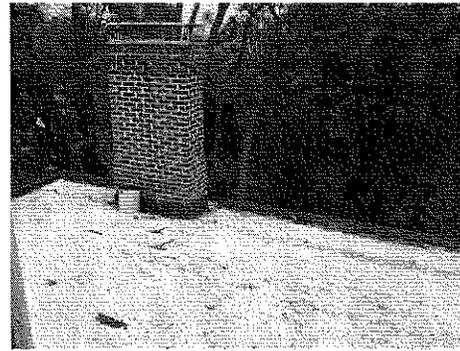
View at main roof looking southwest

The roofs (both main roof and roof at the two story kitchen portion of the house in the rear) are metal (tin) roofing with integral yankee gutters and leaders. The roof should be replaced including gutters, leaders, soffits, flashings, etc. There is extensive water damage at the main third floor and servant's quarters the rear second story reflecting a history of failings at the roof system. Gutters were observed full of still water that was not draining and in one instance dripping through seams in the wood fascia, soffit, and trim of the yankee gutter enclosure causing further damage to the building.

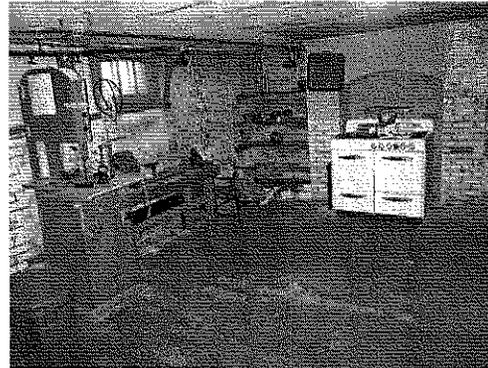
Typical view at cellar space.

The cellar has a musty smell upon entering due to moisture. While no standing water or leaks were observed during our visit, there is clearly moisture in the space. The plaster ceilings are damaged and need of repair in some locations. There are existing items from the current owner in the cellar. Amongst these items are what appear to be the removable screens for the ground floor windows. The quantity was not determined to verify that all of the screens were intact and accounted for.

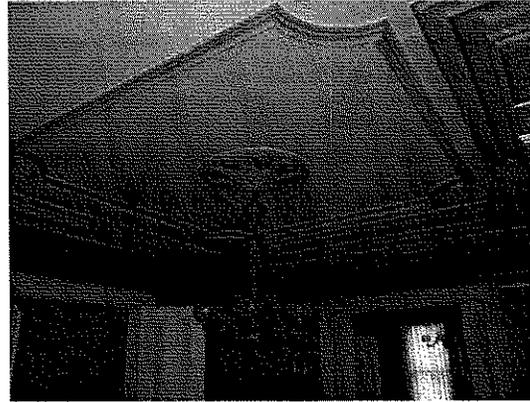
Typical view at ground floor ceiling and space.

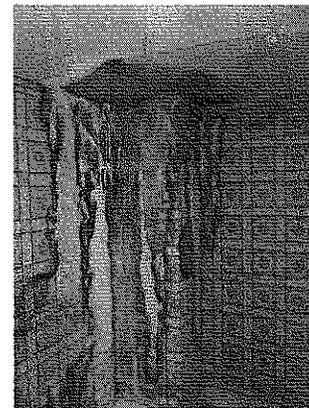
These rooms have signs of significant water damage on their walls and ceilings. While there were no signs of a current water infiltration problem, it is clear there is a history of water problems in both of these rooms stemming from roof flashing failures at the existing chimney above. The ceilings here are \pm 7'-6" high. The rooms have exposed wiring. The floor tile in Bedroom 2 is questionable and may contain hazardous materials and should be tested.

Water damage at servants' bedroom.

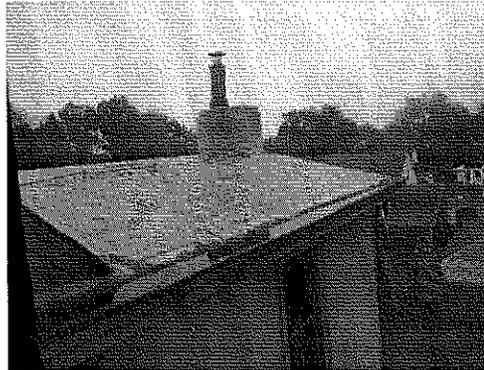
View at roof over kitchen portion of house.

The roof shows signs of attempted makeshift repairs, mostly at vertical penetrations, with asphaltic roofing patch materials that are not consistent with the existing roofing system. A can of the aforementioned asphaltic patch is still resting on the roof and presents a hazard if blown off. The existing brick masonry chimneys, need to be repaired and repointed in some instances and the caps investigated and repaired/restored as necessary.

Most gutters were full of water on the day we visited. The storm water drainage system is clogged and not draining properly. This will need immediate attention as water was observed dripping from the wood trim work concealing the gutter systems. Most soffits at roof overhang show deterioration and/or damage and will need repair/replacement work.

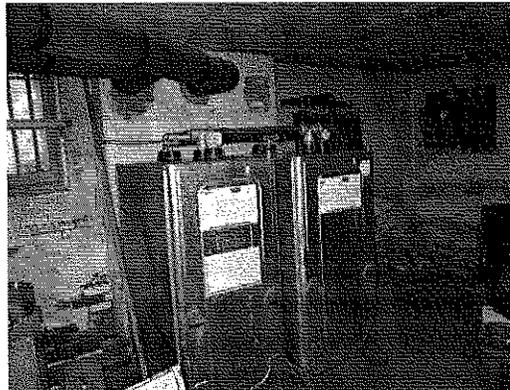
The furnace is Model Number 392E-048200, Series A, Serial Number LF 912383001, 200,000 BTU as manufactured by BDP Company (related to Carrier). The oil tanks are DWT Series Type 1000 I/H 275/200 as manufactured by Roth with Serial Numbers: 0850805313888 and 0810505312290. The oil tanks appear in good condition and reasonable new. The furnace appears older but in fair condition. We would recommend testing the furnace and entire heating system to verify that it is operating correctly and sufficiently heat the residence.

Oil storage tanks.

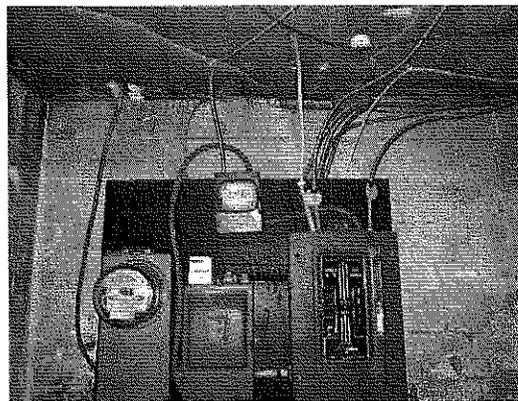
The building is provided with a 100 AMP service located in the north west corner of the cellar. The service is fed from a utility pole on the opposite side of East Passaic Street overhead to the residence and runs down the exterior of the residence to the cellar. The main panel is a 100 AMP, one phase, three wire 120-240 a.c., catalog number NBS310C as manufactured by Federal Noark. The PSE&G/General Electric meter number is 12711620886330. The electric service is inadequate for a structure of this size and is antiquated. We would recommend an upgrade and new service to be installed.

View at electric service.

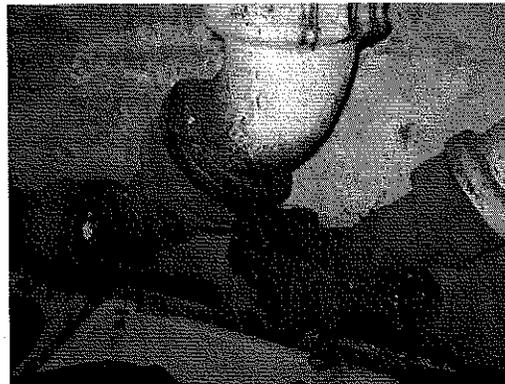
Some significant staining and rusting was observed on the main sanitary line in the cellar and vertical stacks on the second and third floors. Some shut off valves in the cellar have decay and build-up and should be replaced at some point. The main sanitary line exits the cellar subgrade out the east side of the building.

Rusting, staining and moisture at sanitary line.

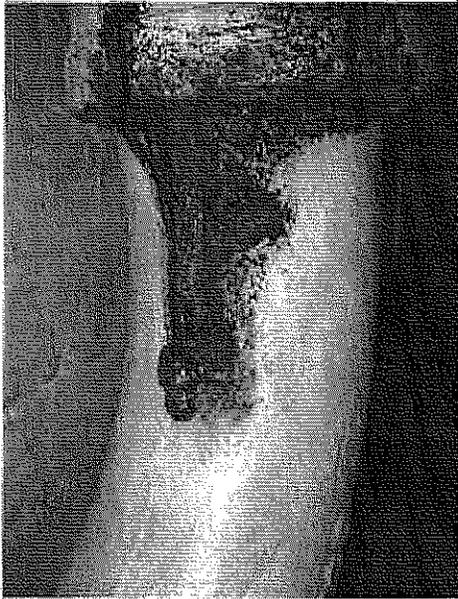
LEAKING/STAINING @ MAIN SUPPLY LINE

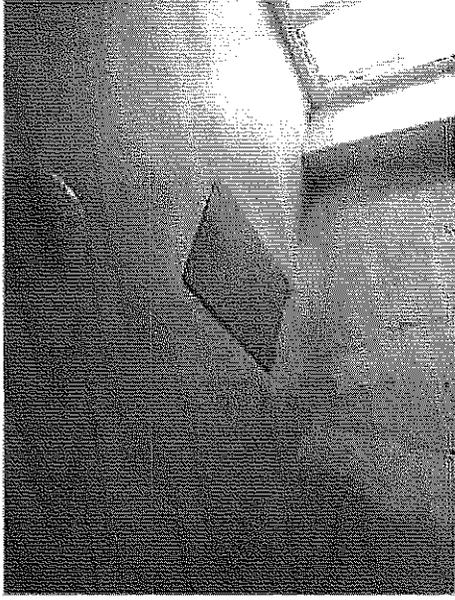
WALL/CILING DAMAGE 2ND FLOOR BATH

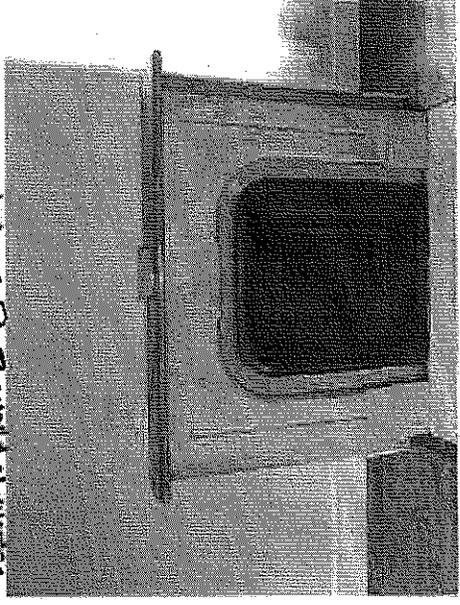
FIREPLACE C BR 1 - DAMAGED KEYSTONE
PLAQUE

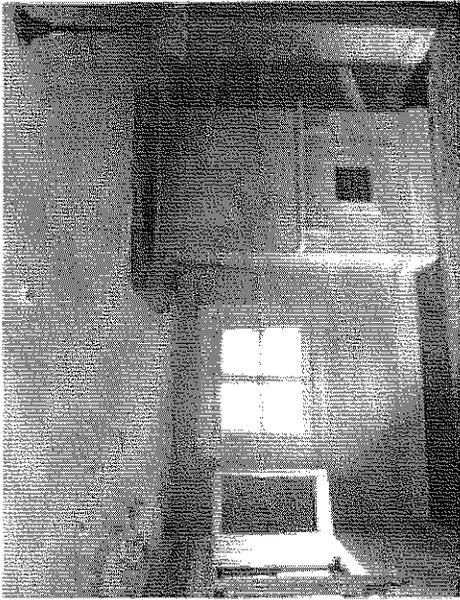
BR-5 @ 3:00 PM - WATER DAMAGED UNIT

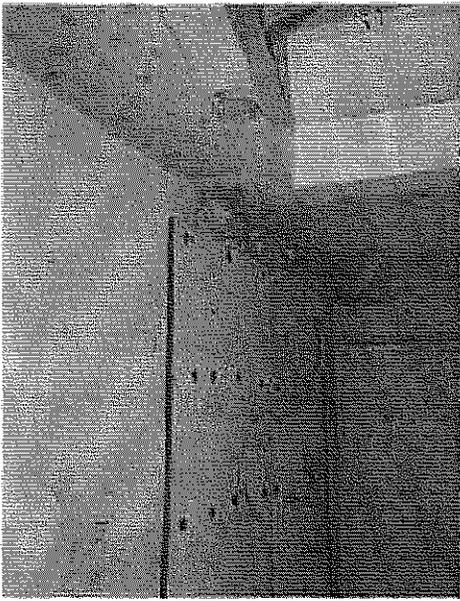
BR-6 @ 3:00 PM - WATER DAMAGED UNIT

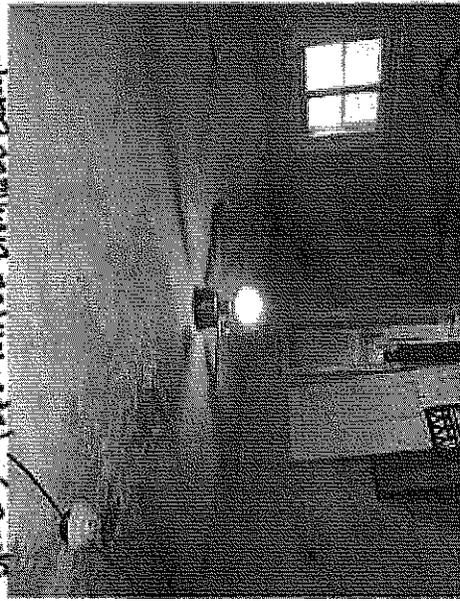
BR-7 @ 3:00 PM - WATER DAMAGED UNIT

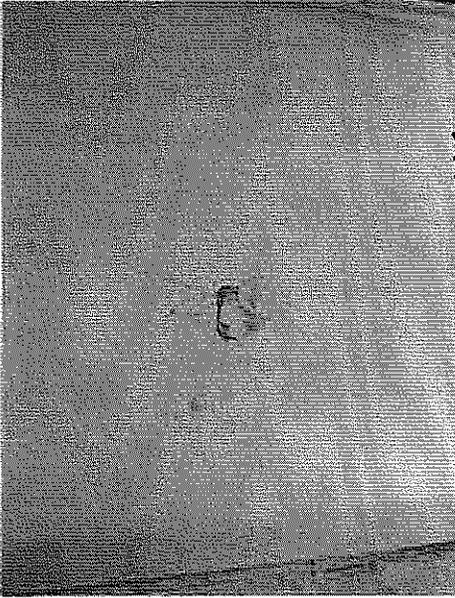
IMPACT DAMAGE C 100 FT SE 300 FT

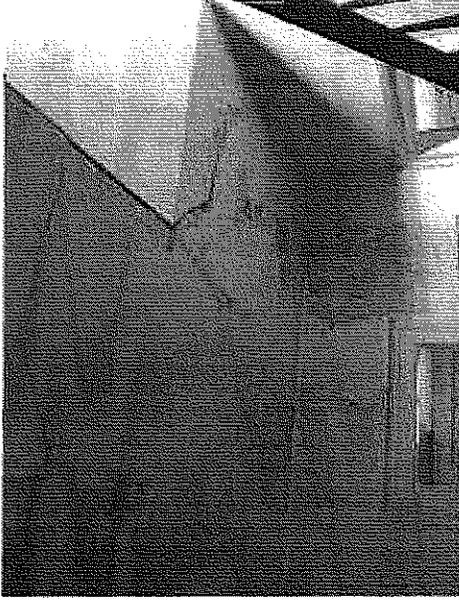
CONCRETE DAMAGE

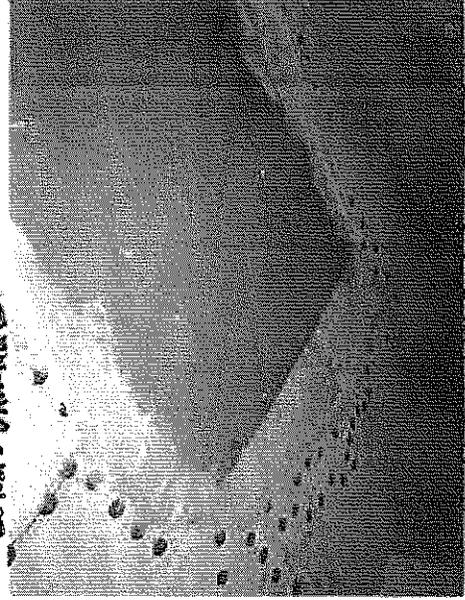
CONCRETE DAMAGE 3/10 PM

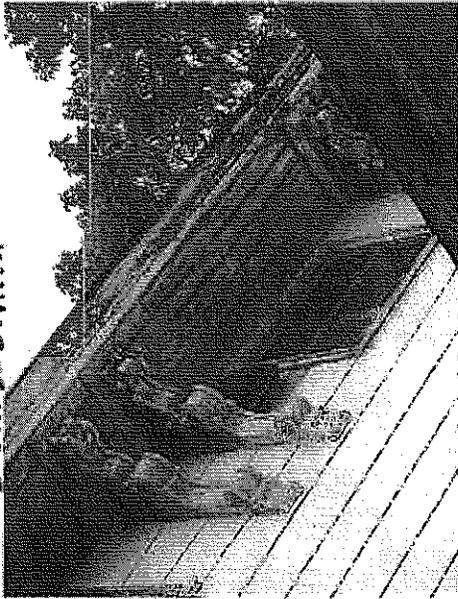
DAMAGED ROOF

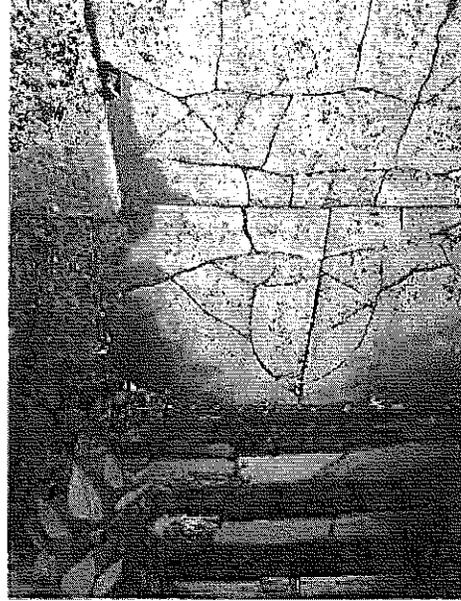
CRACKED SIDE WALL

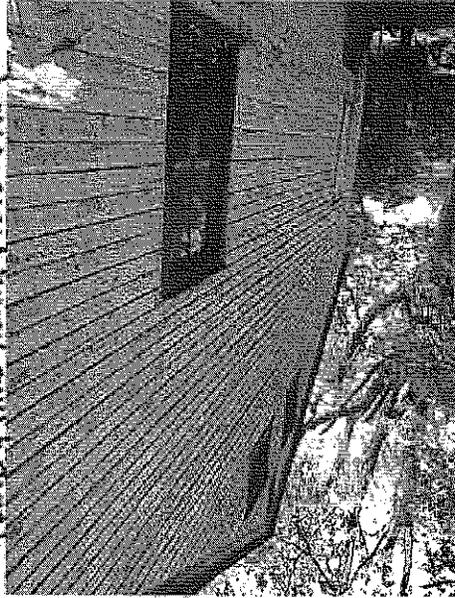
CRACKS IN WOOD SIDING
