**BUILDING EVALUATION REPORT
BASED UPON VISUAL OBSERVATIONS
AT**

“CAPTAIN WILLIAM TYSON HOUSE”

**49 EAST PASSAIC STREET
TOWNSHIP OF ROCHELLE PARK
BERGEN COUNTY, NEW JERSEY**

JUNE 1, 2015
PREPARED BY

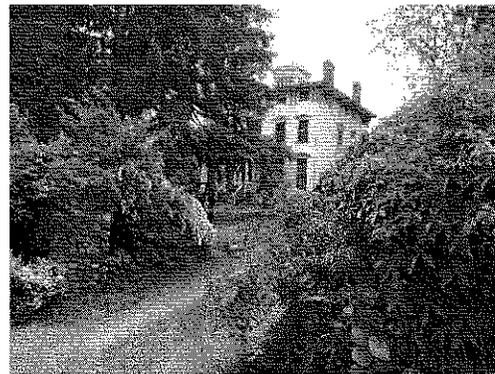
Along East Passaic Street, both curb cuts are framed by rubble stone masonry piers. A pedestrian entrance to the site towards the center of the property has smaller rubble stone flared retaining walls and stair risers up to the front yard which is accessed by a bluestone walk. The stone pillars are in need of some repointing of the mortar joints as stones could be pulled out by hand during our visit. The bluestone stair treads and walkway are in fair condition, but some treads are missing stones and some have chipped corners and edges. The public sidewalk along E. Passaic Street is cracked and damaged in need of repair, or more likely full replacement.

View from west entry drive from East Passaic Street

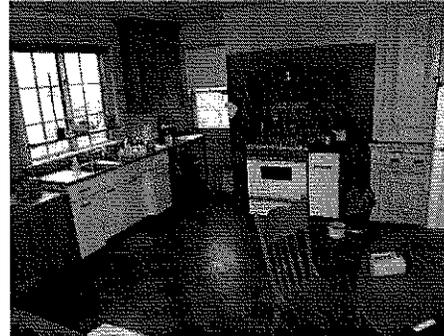
View at ground floor kitchen.

The kitchen area is down two steps from the main ground floor area ($\pm 16''$ total). The large kitchen area has a makeshift collection of original and newer cabinetry, plumbing, appliances, etc. The kitchen has a double sink, refrigerator, and gas range/oven. The walls have wall paper and the ceiling is painted with a surface mounted strip fluorescent light fixture with prismatic lens. The flooring has a $\pm 8'' \times 8''$ tile that is questionable and may contain hazardous materials. These tiles and adhesive should be tested by a qualified environmental company.

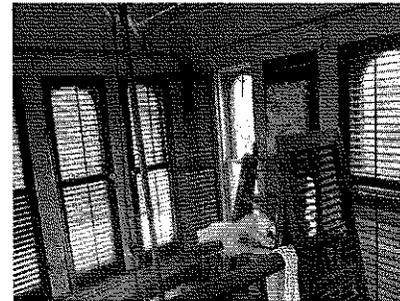
The cupola at the top of the structure has some plaster cracking and paint peeling as with other areas of the building. Arch top windows with shutters line all four sides of the small space that needs to be cleaned out of all of the items stored here. And while visibly not square from below, the cupola appears structurally sound.

View inside cupola.

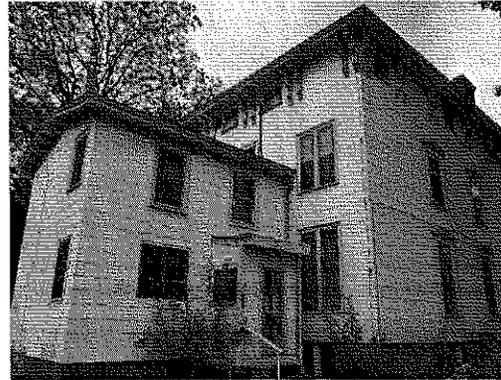
The east façade is consistent with the north in terms of description and deficiencies. The 'bilco' type hatch with stair to access the cellar is on this side of the house. The cable service wire comes to the house overhead at the north corner of this façade and runs exposed to the south corner where it enters the building. Also on this façade is a small mudroom addition with makeshift stairs and railings that should be replaced. It appears that the window over the kitchen sink at the rear portion of the house is not original.

View towards east façade.

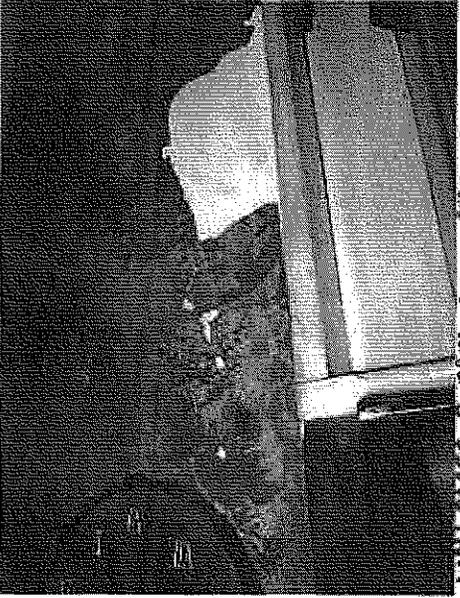
WALL HOLE & PATCH 1 - 4700 BA.

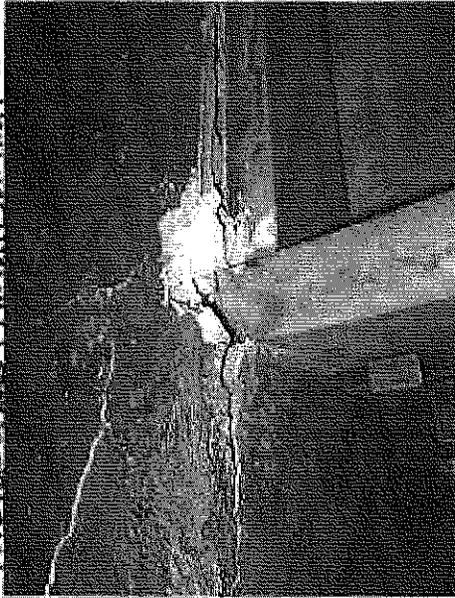
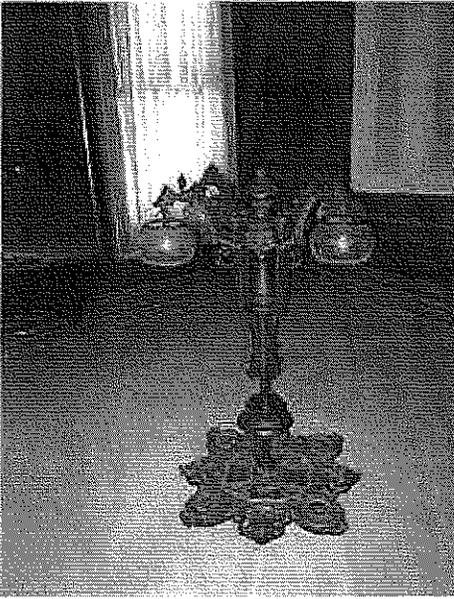
LIGHT FIXTURE & PANEL 2 - GOOD PH.

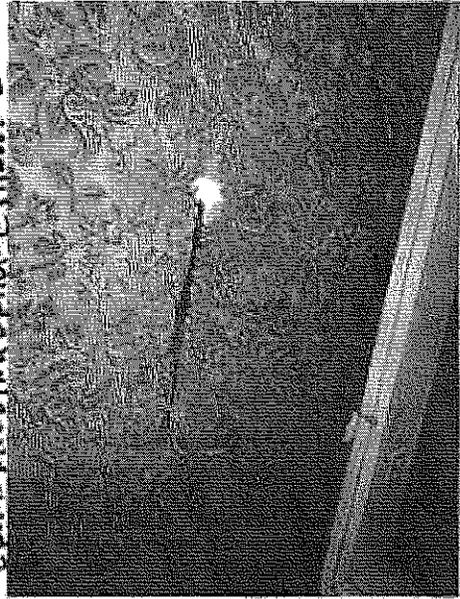
DAMAGED WITH PAPER PANEL 2

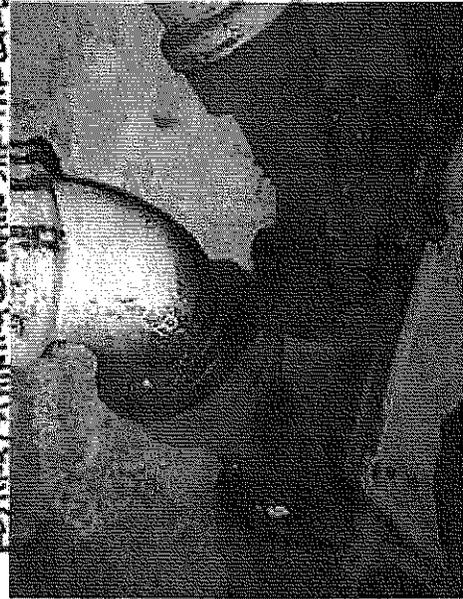
MAIN SUPPLY LINE @ CELLAR

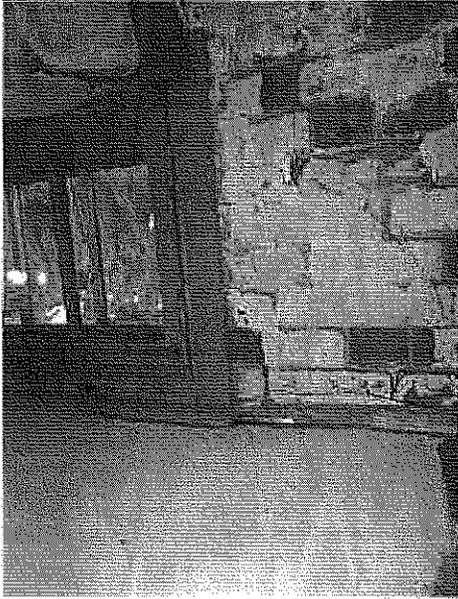
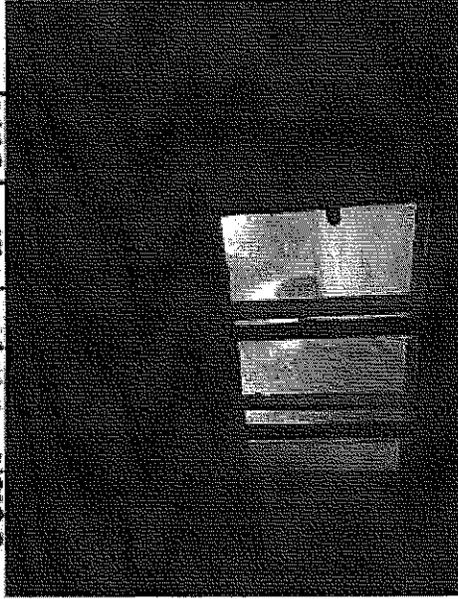
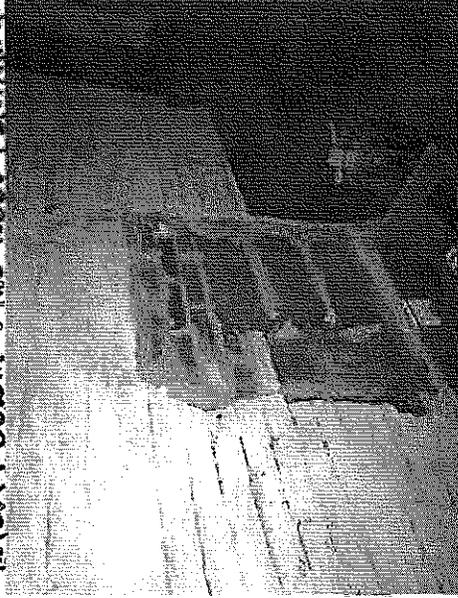
WATER DAMAGE & CELLAR WALL

DAMAGED VALVE & CELLAR

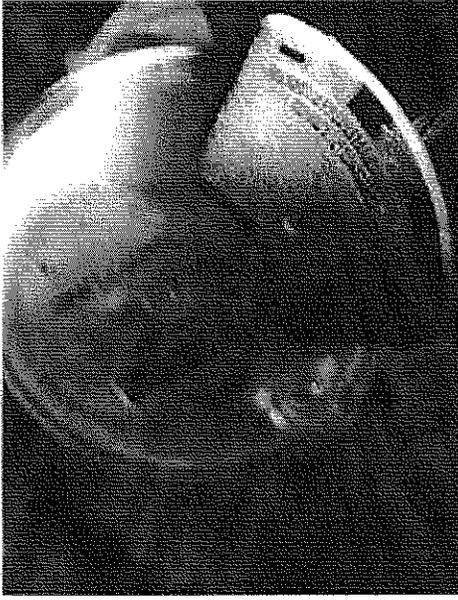
WATER METER - 2ND FL

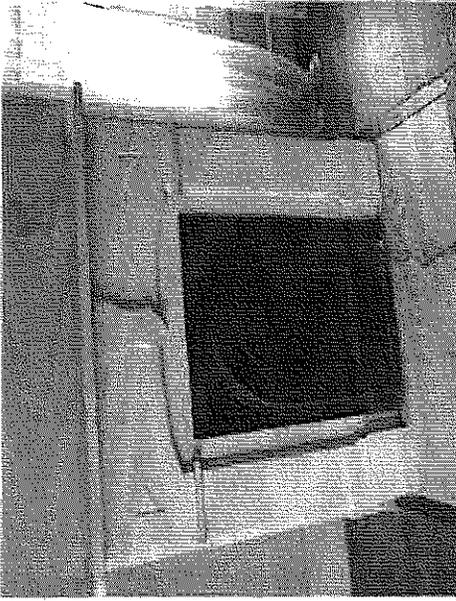
EXPOSED NON-BELESS ED SMOKE ALARMS
-2ND FL.

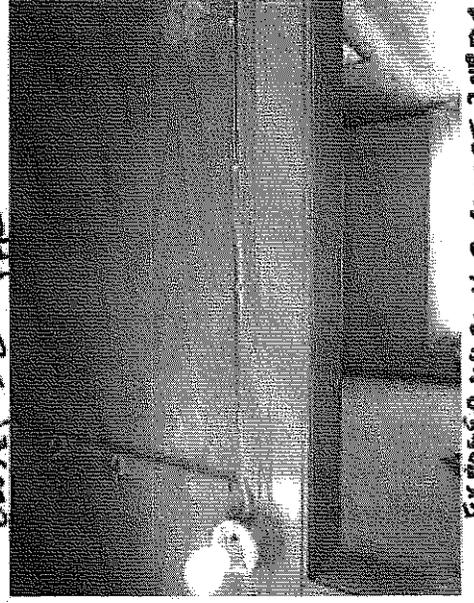
EXPOSED WIRING CLOSET - 2ND FL.

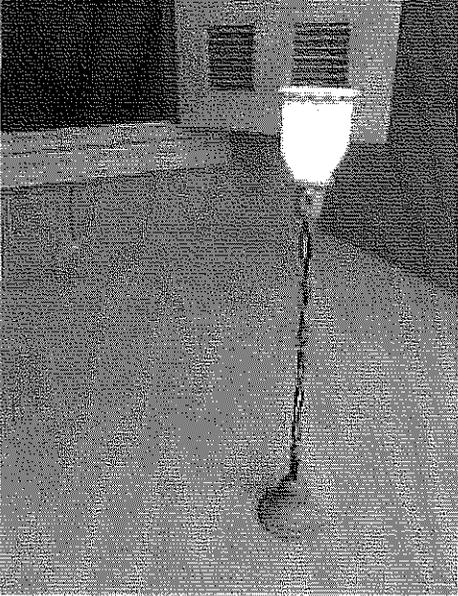
EXPOSED STUDS AND RAFTERS UNDER ZIP

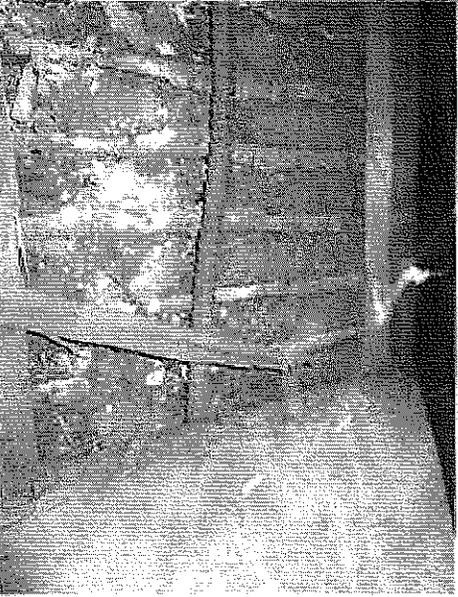
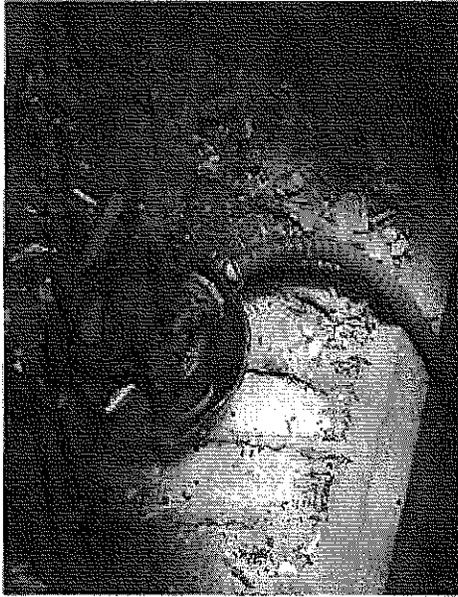
OPEN ELECTRICAL BOX - CONCRETE IN PROMPT

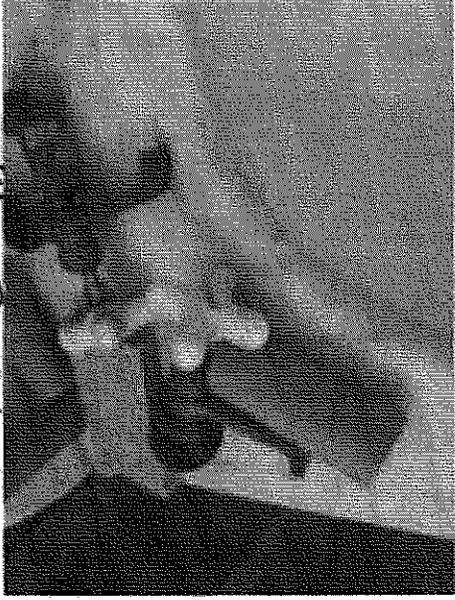
WALL/CILING DAMAGE 2ND FLOOR BATH

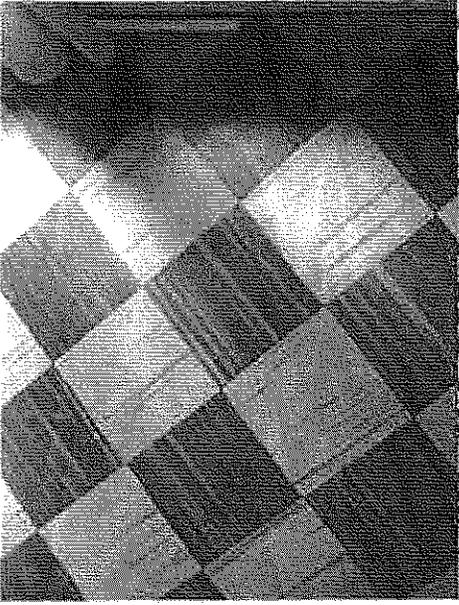
QUESTIONS RE TILE SEPARATION

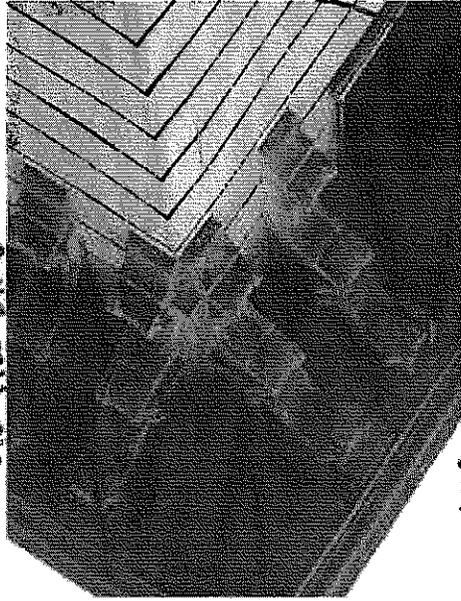
TYP. MAIN ROOF GUTTER DETAIL

The roofs (both main roof and roof at the two story kitchen portion of the house in the rear) are metal (tin) roofing with integral yankee gutters and leaders. The roof should be replaced including gutters, leaders, soffits, flashings, etc. There is extensive water damage at the main third floor and servant's quarters the rear second story reflecting a history of failings at the roof system. Gutters were observed full of still water that was not draining and in one instance dripping through seams in the wood fascia, soffit, and trim of the yankee gutter enclosure causing further damage to the building.

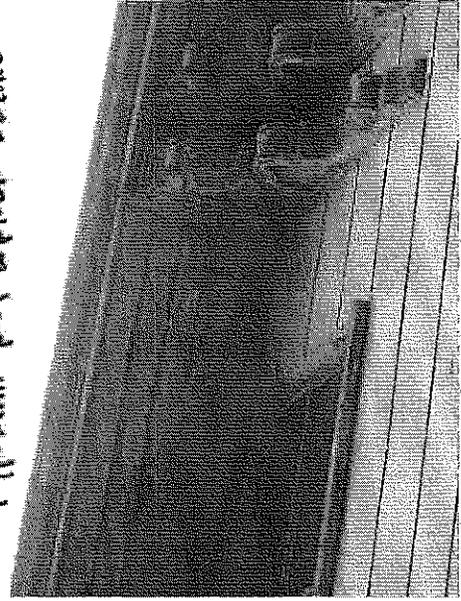
DAMPENED SUPPORT

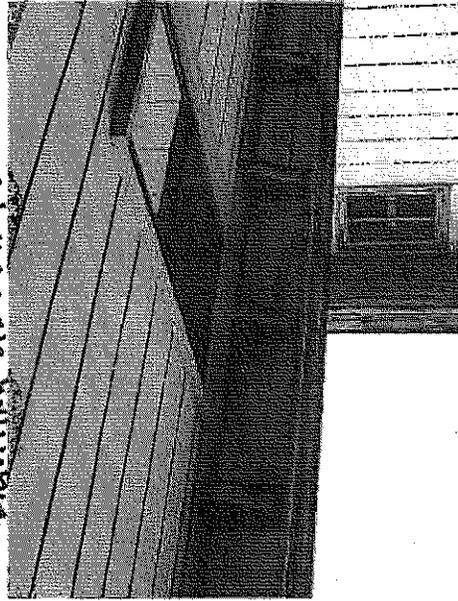
SOFFIT @ 2-37 PM BUDG

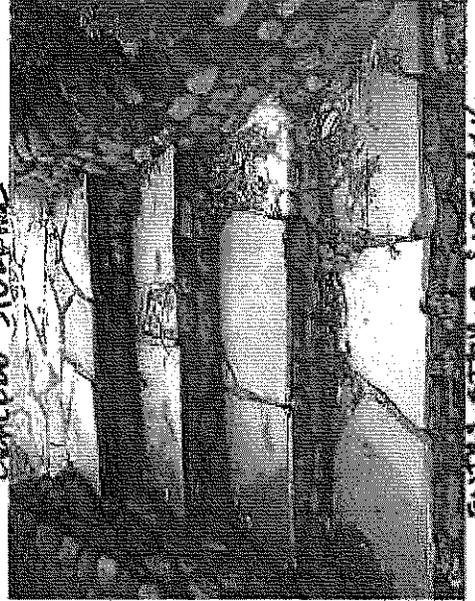
EAST SIDE & SIDE WALL

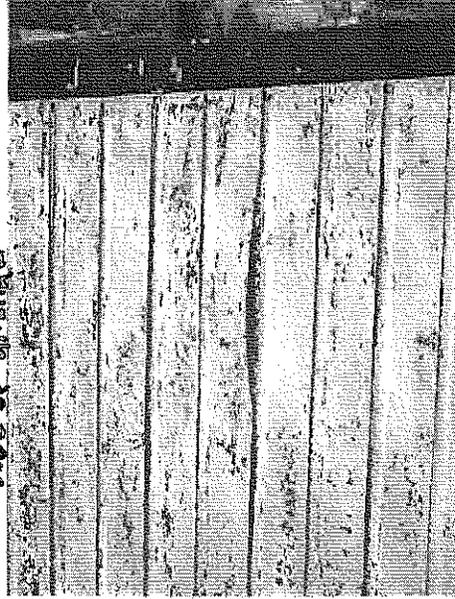
SIDING & GARAGE
